# Jamestown Apartments Stream Restoration Project

Construction  
Fall 2006

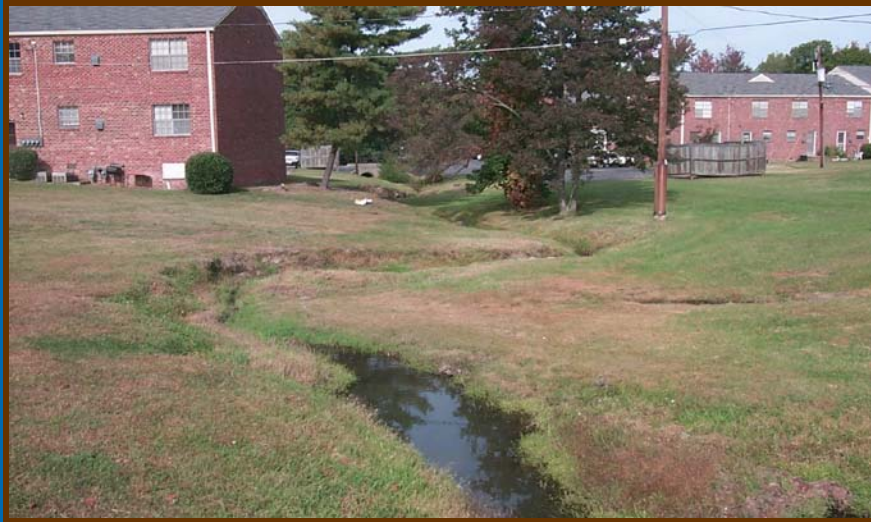
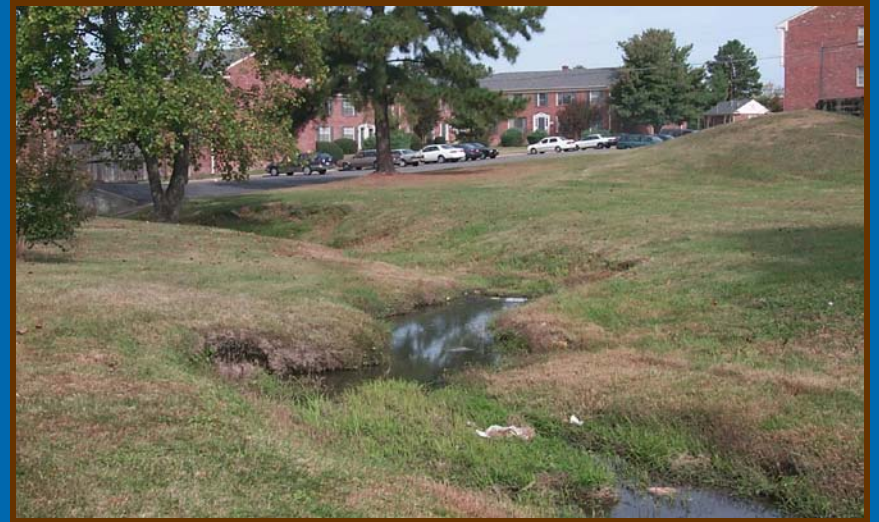
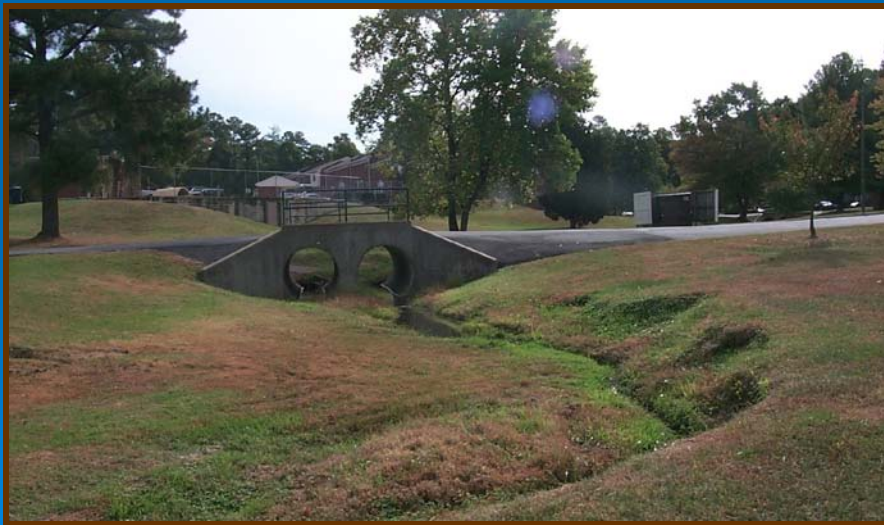
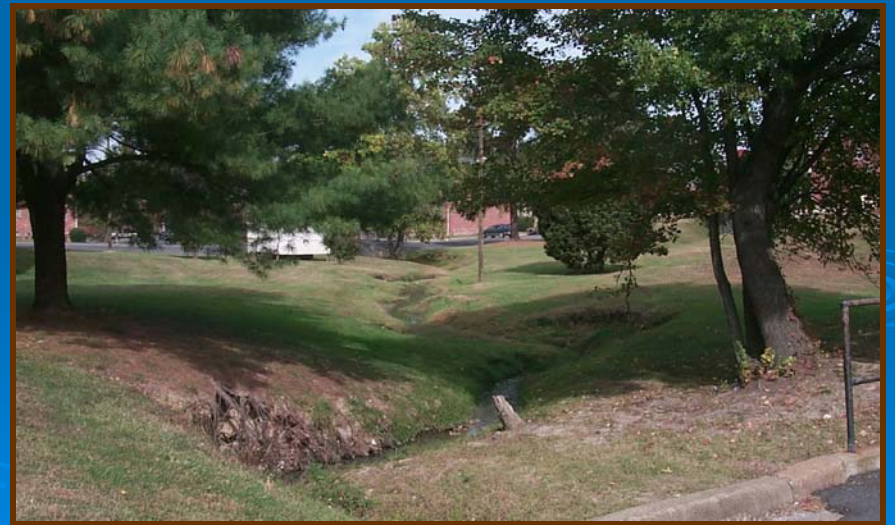
# Lack of Vegetated Buffer

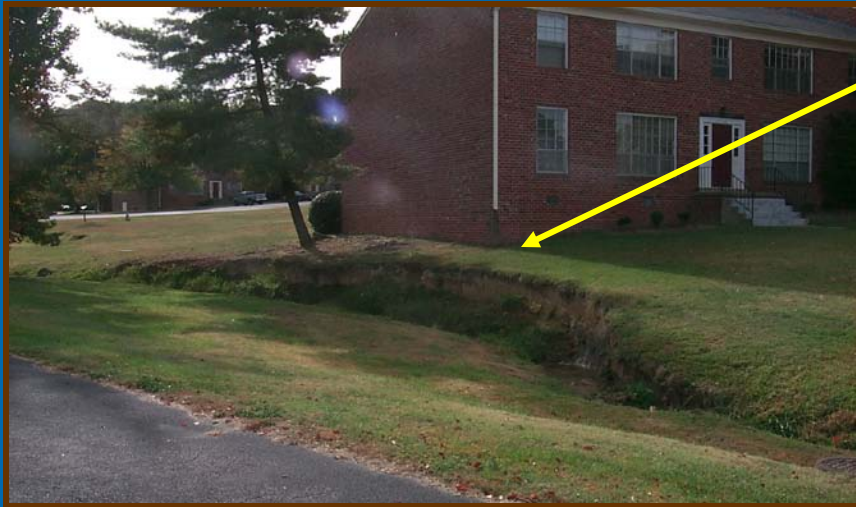
# Existing Erosion Areas

Erosion endangering building foundations

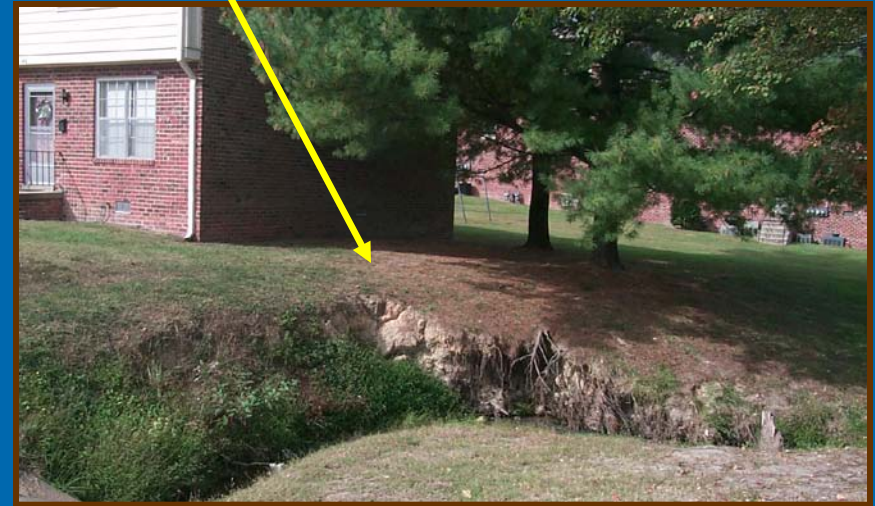
Erosion threatening parking lot integrity

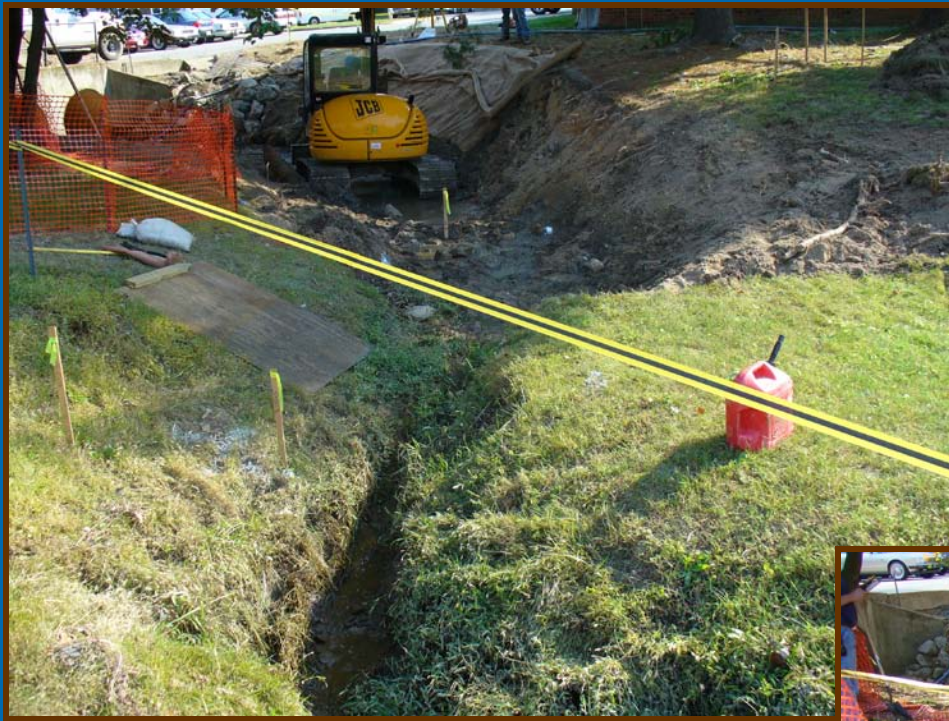
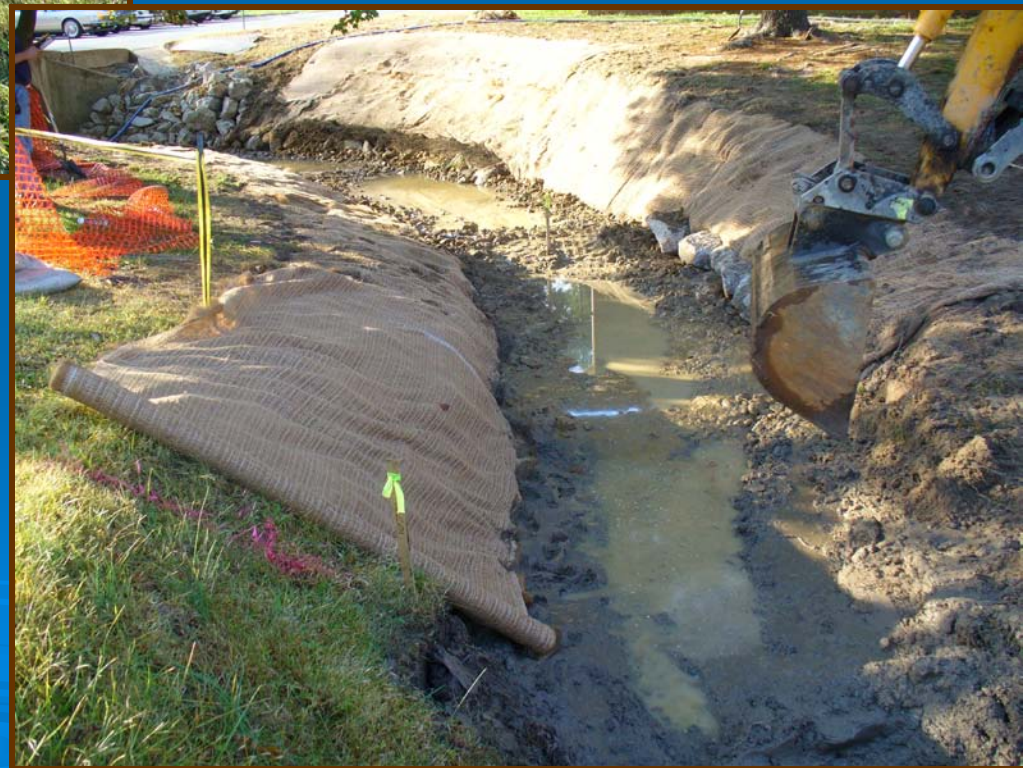
Stream channel  
widened and stream  
slope varied to reduce  
velocities in channel

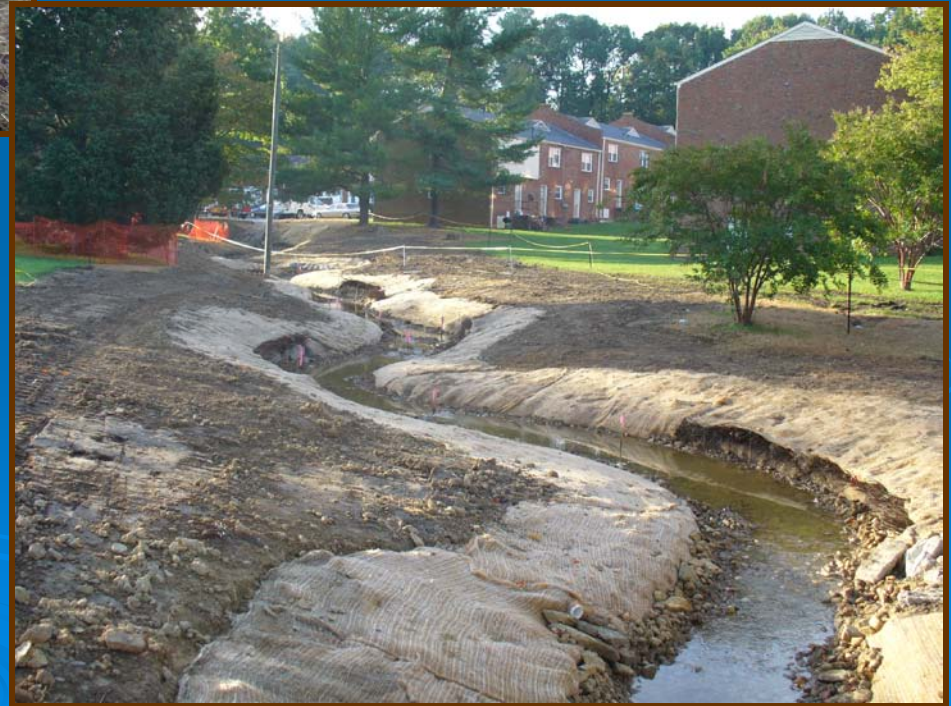
Stream widened and  
meander established

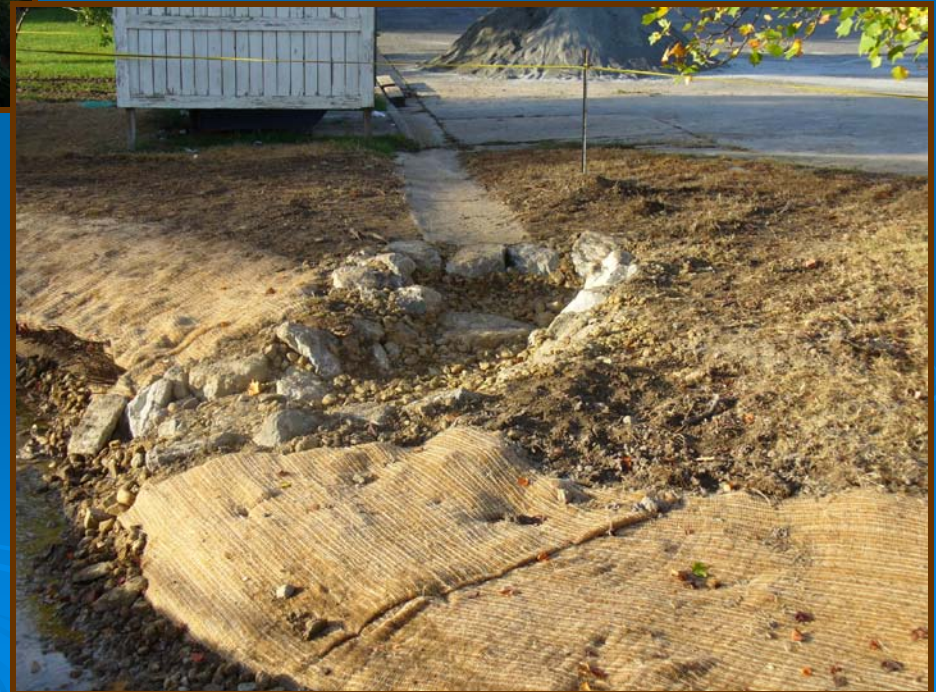
Paved ditch replace  
with Step Pools and  
Rock Cascade

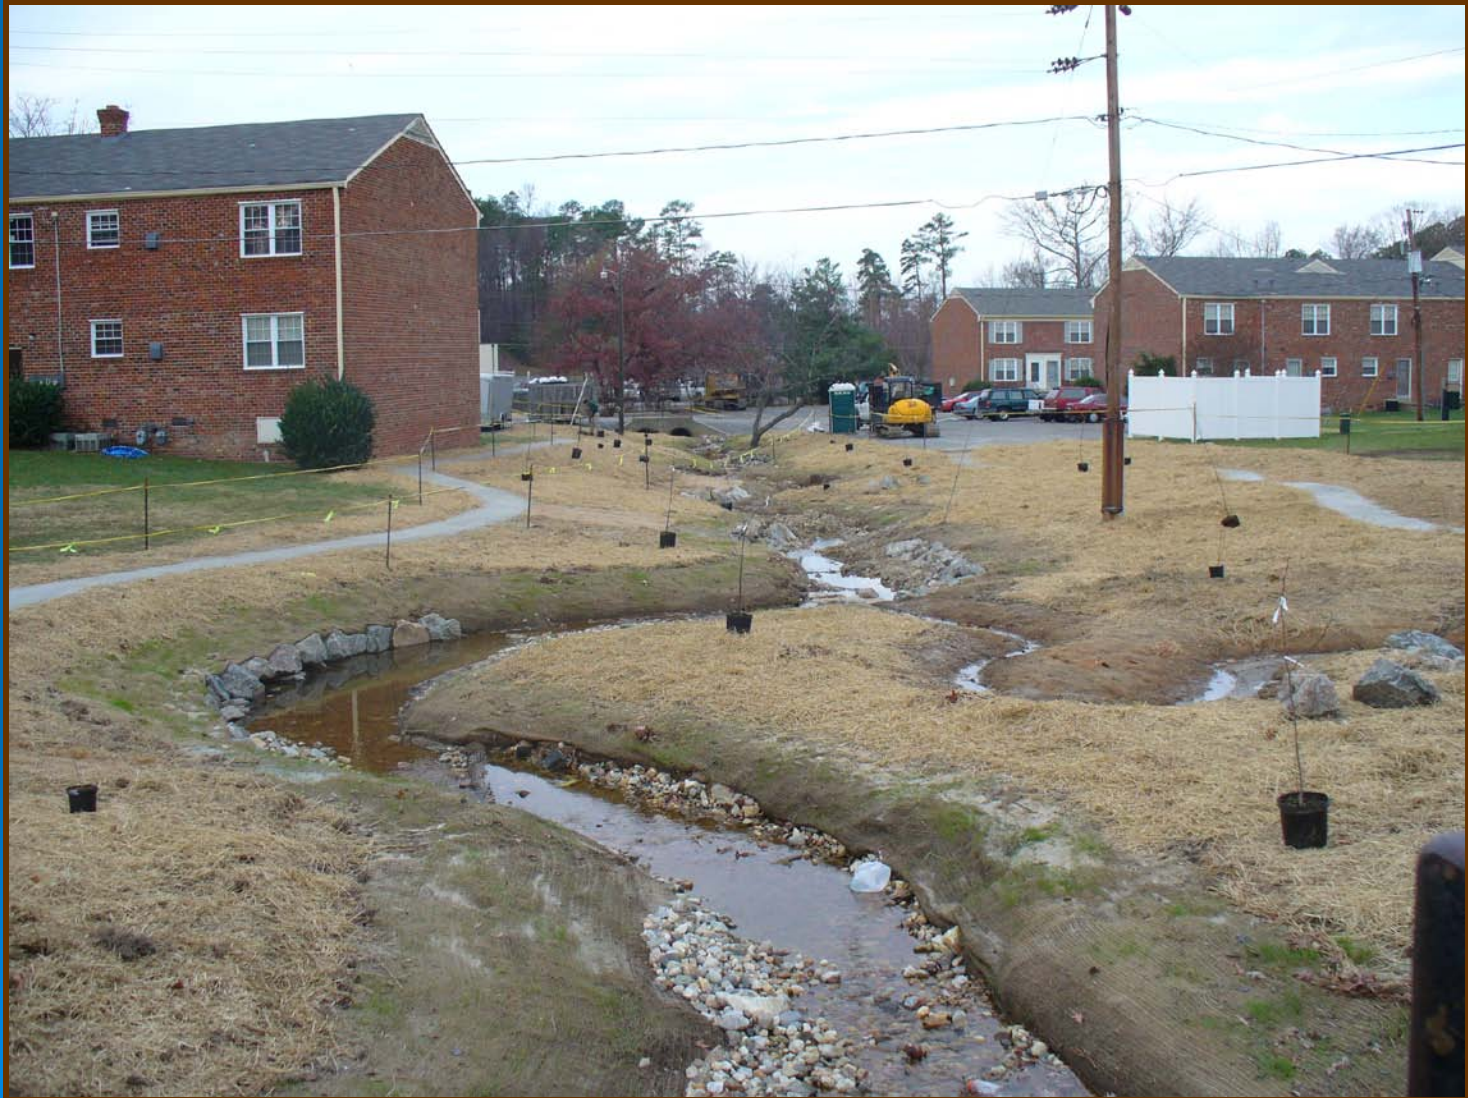
# Plant Installation

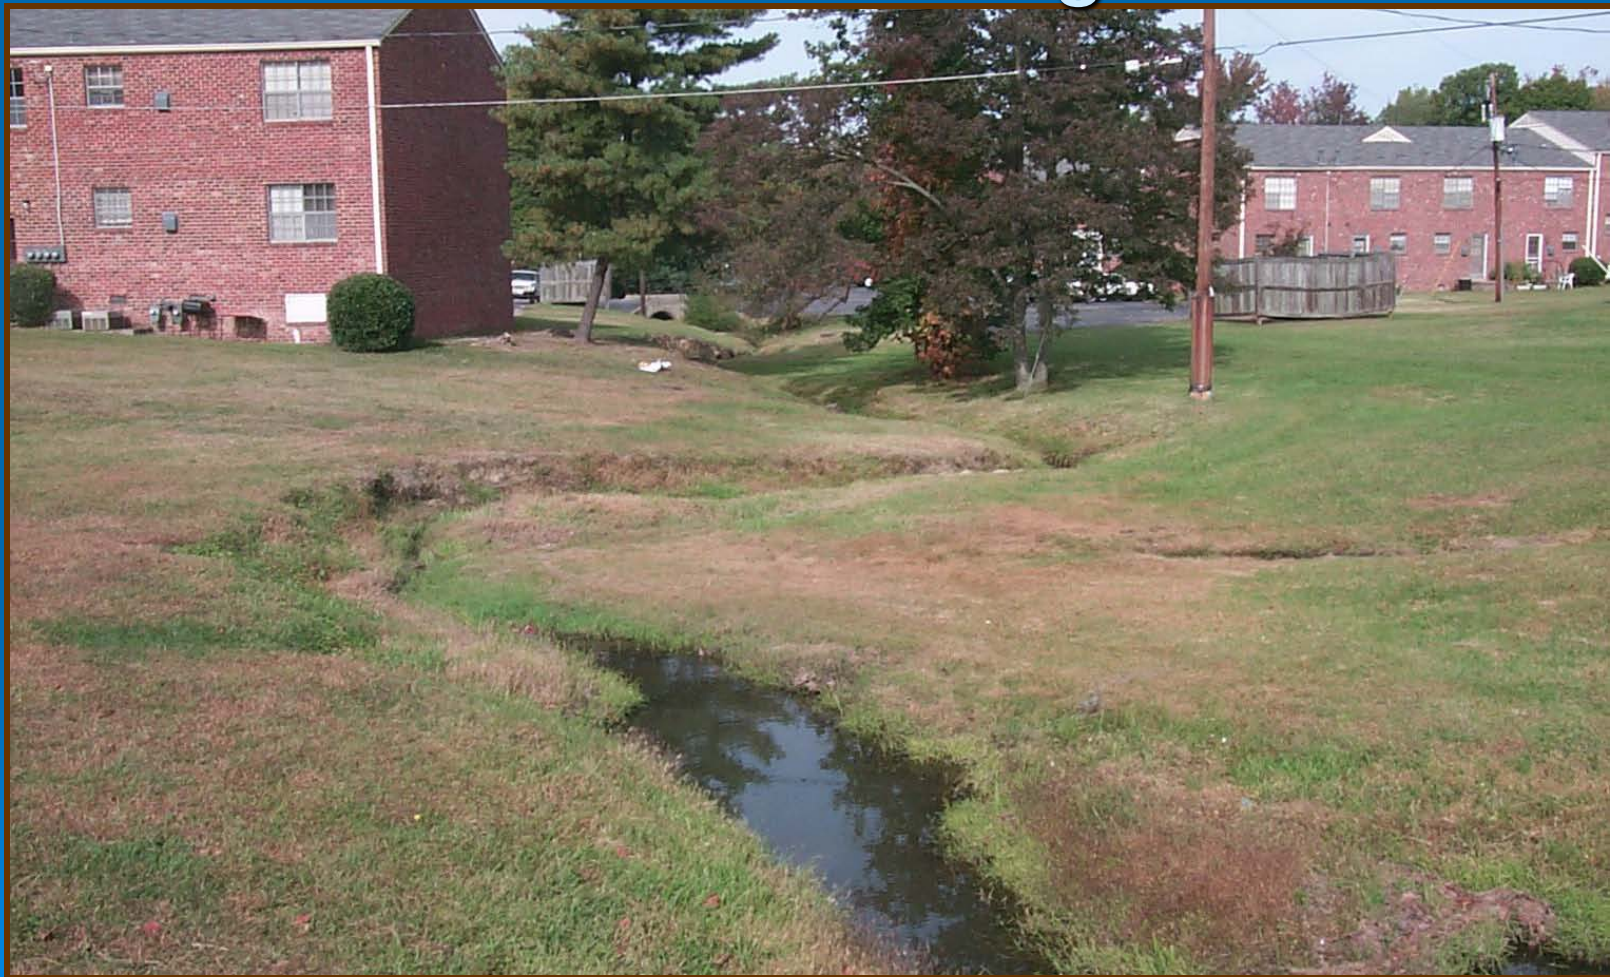
The project is a success. The stream was transformed from an eroding channel with little vegetation...

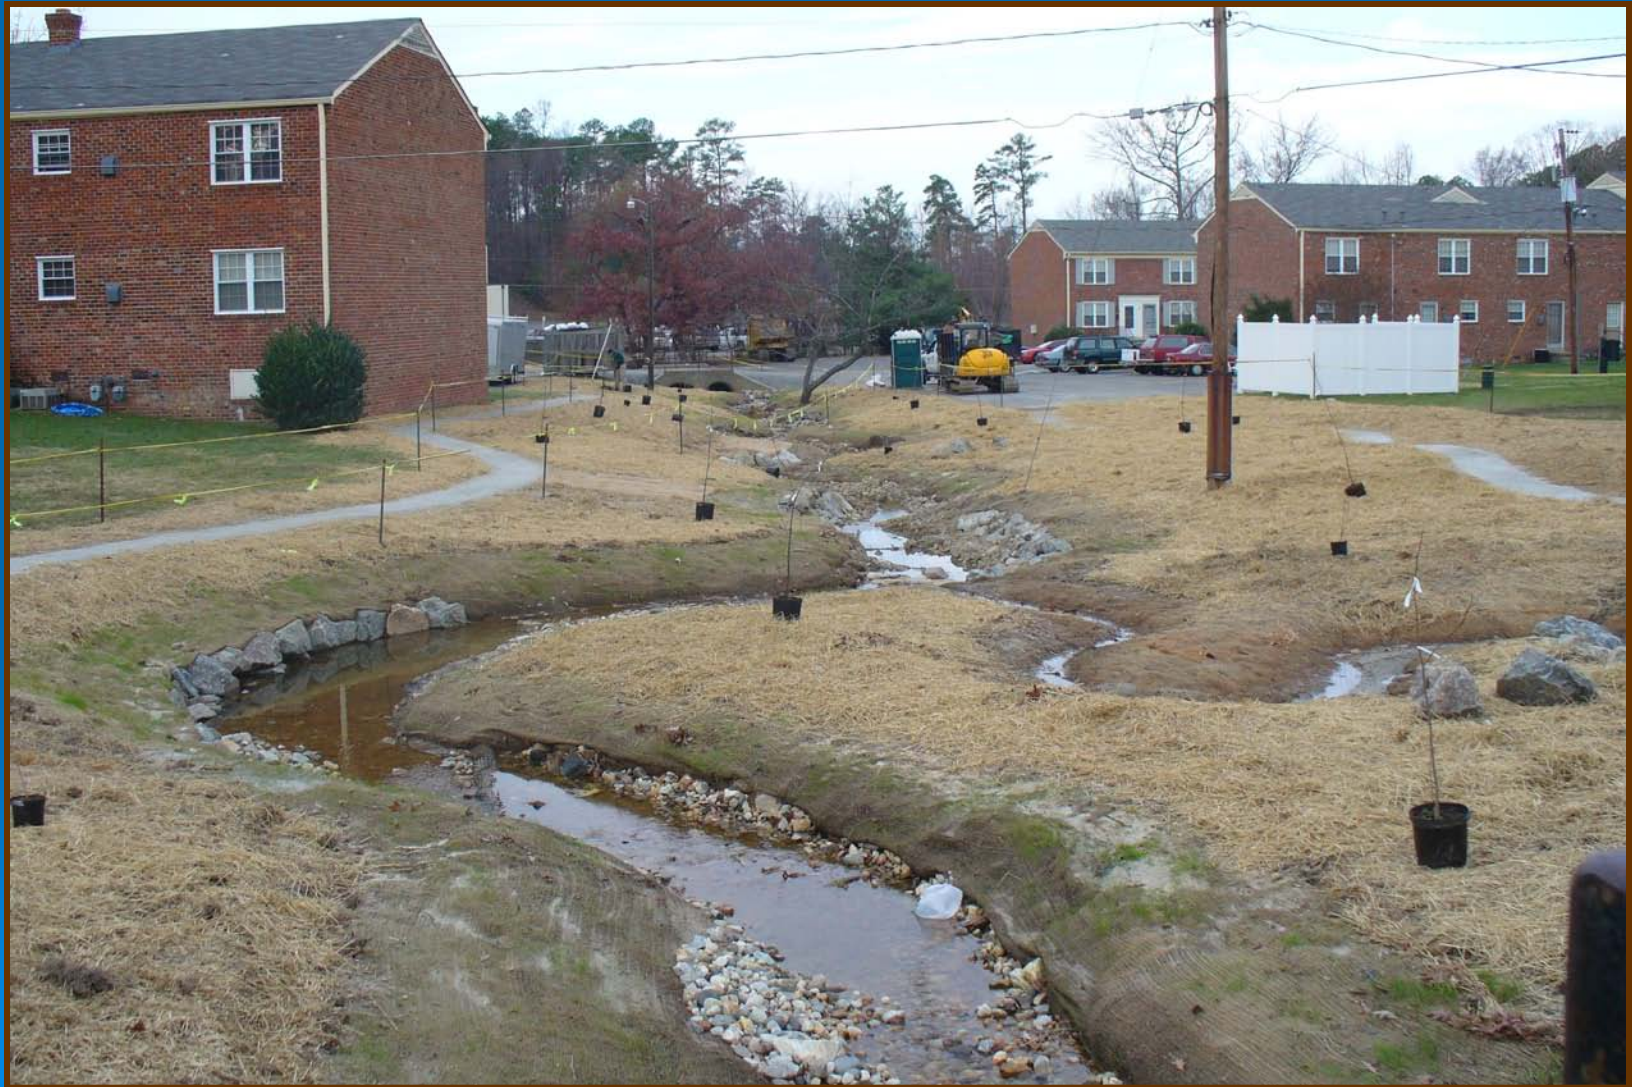
to a stabilized stream...

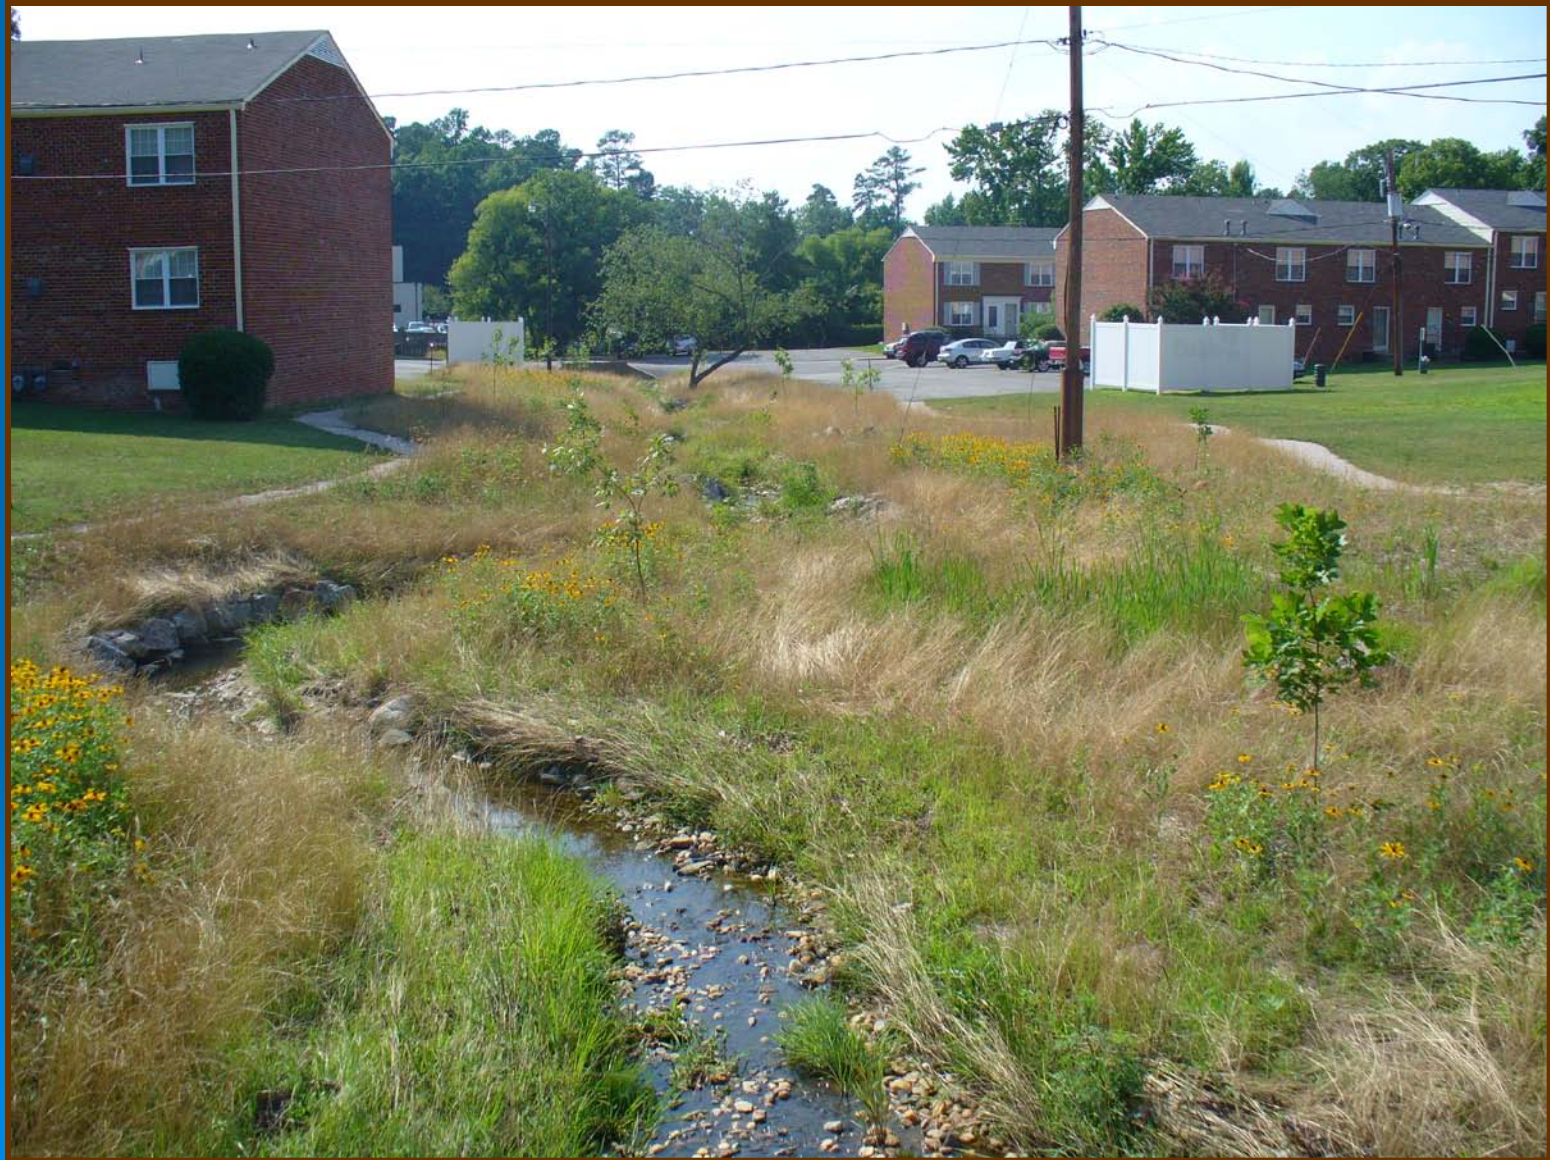
with a beautiful native buffer.
